**Flood Control Project Maintenance
Levee Inspections**

Maintenance Issue Types Only, Levee Inspection Report By Mile - Spring 2017

Sacramento Maintenance Yard East Levee Yolo Bypass

Waterway	Bank	Unit Miles	Inspection Start/End	Inspector
Unit No. 01 Yolo Bypass	Left	2.01	04/11/2017 04/11/2017	Zach Jojola

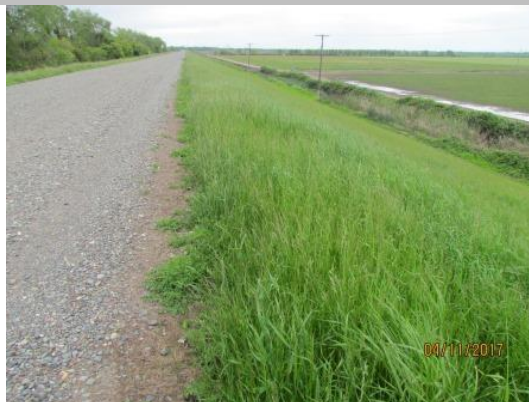
Photo 1 of 1 : SP_2017_ST0004_41_7_20170413_00006.jpg

LM Start	0.00	Rating **	M	Issue No.	7
LM End	2.01	Issue Type +	Ma	Location *	LS
Category	Earthen Levee			GPS Latitude/Longitude	
				Start	End
Item	Vegetation			38.765342°	38.736315°
				-121.635056°	-121.633680°
DWR ID	DWR_ST0004_01_s_2017_7				
Comment Code					
V1 : Control annual grass and weeds on the levee slopes and easements.					
Inspector Comment

Tall grass on landside levee slope, blocking visibility. Spring 2017.

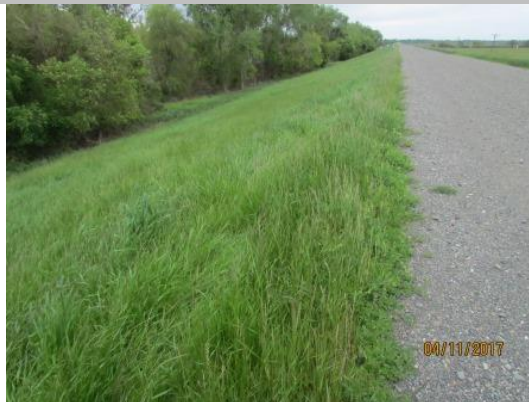
Photo 1 of 1 : SP_2017_ST0004_41_8_20170413_00007.jpg

LM Start	0.09	Rating **	M	Issue No.	8
LM End	1.64	Issue Type +	Ma	Location *	WS
Category	Earthen Levee			GPS Latitude/Longitude	
				Start	End
Item	Vegetation			38.764109 °	38.741661 °
				-121.635551 °	-121.634064 °
DWR ID	DWR_ST0004_01_s_2017_8				
Comment Code					
V1 : Control annual grass and weeds on the levee slopes and easements.					
Inspector Comment

Tall grass on waterside levee slope, blocking visibility. Spring 2017.

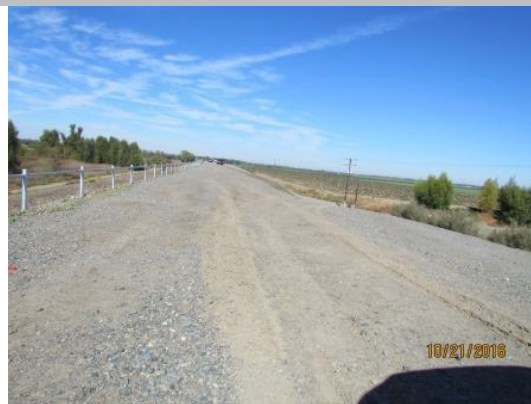
Photo 1 of 1 : SP_2017_ST0004_41_2_20170320_00003.jpg

LM Start	1.21	Rating **	M	Issue No.	2
LM End	1.21	Issue Type +	Ma	Location *	CR
Category	Earthen Levee			GPS Latitude/Longitude	
				Start	End
Item	Crown Surface / Depressions / Rutting			38.747823 °	38.747823 °
				-121.634418 °	-121.634418 °
DWR ID	DWR_ST0004_01_f_2016_2				
Comment Code					
C2 : Repair depressions or ruts in the crown or slope.					
Inspector Comment

Ruts on levee crown. Fall 2016.
